# Alert Workshop

## Experience and Lessons Learned

### EA-2008- MPA-13-A: Marotta Fill and Vent Valve leakage

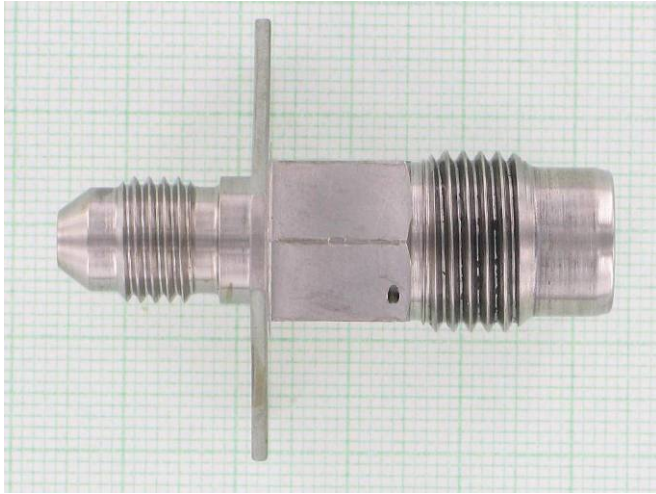
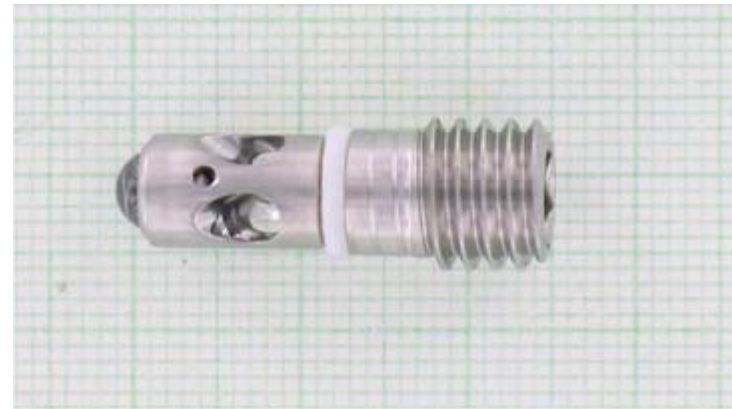
- During the launch campaign, the system leak test showed an excessive leak rate.
- The part had a history of leak problems, also in other projects (Rosetta, MetOp, Integral)
- To eliminate the risk of an unpredictable evolution during mission, the part was replaced with the spare unit.
- IPN # 143 was issued.
- The removed part was brought back and subject to destructive inspection by the Estec QM Labs. Results showed contaminants and damage on the sealing surface. An hypothesis on the failure mechanism was proposed.
- The alert was generated with preventive and corrective actions for the supplier, and recommended actions for the part user.

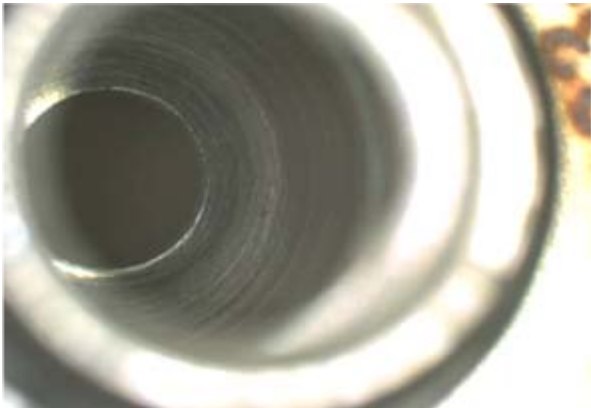
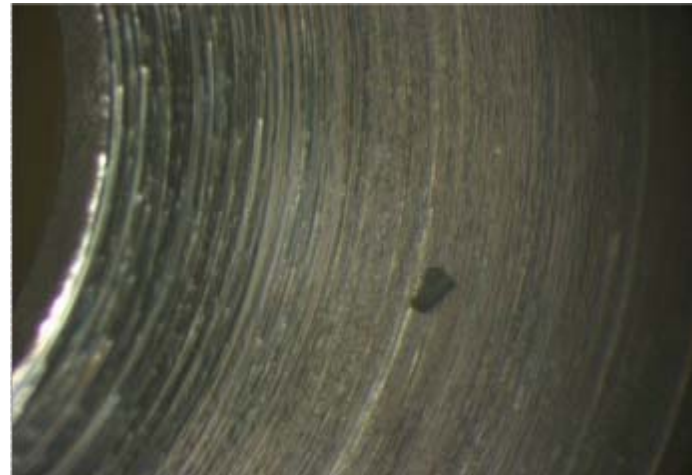
- A particle on the seal area (below)
- Deposit of metallic material on the surface of the ball (next)

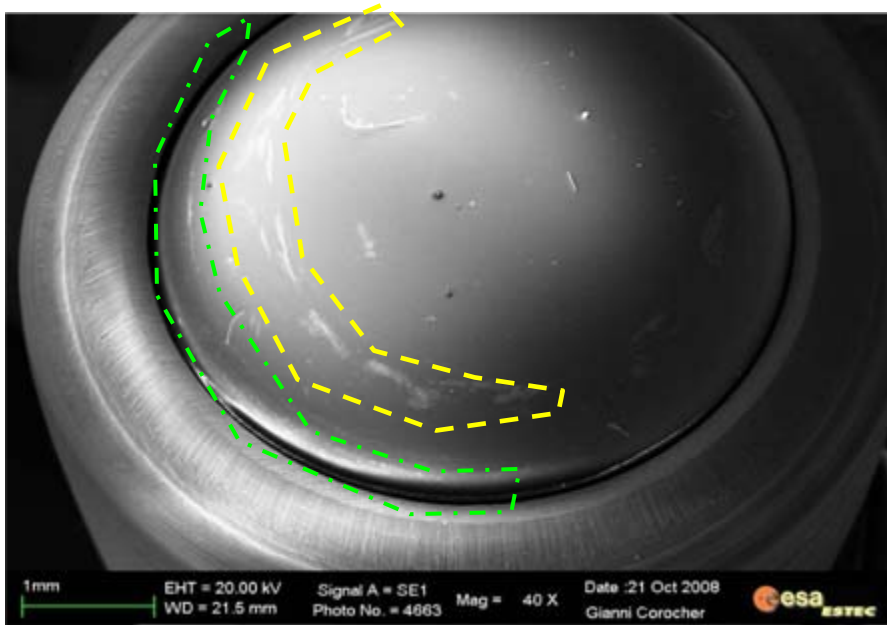
**GOCE SN 004**

<b>GOCE SN 004</b>	<b>Metop SN 212</b>
Contamination in cap screw mechanism and seal (silicon nitride particles, and greasy substance).	Ball move easily on the screw mechanism
Ti6Al4V and Stainless steel deposits on the ball. Smearing of Ti alloy deposit.	Ti6Al4V and Stainless steel deposits on the ball. Smearing of Ti alloy deposit.
Damage to the seal surface, smearing , flaking of material. Orientation of the smearing resembling the deposit visible on the ball.	Part not available
Wear of the surface of the ball support. Smearing of the material. Deep scratches in “not contact area” and presence of particles of silicon nitride.	Wear of the surface of the ball support. Smearing of the material.
Deposit of Ti6Al4V on the surface of the screw mechanism ball support	Deposit of Ti6Al4V on the surface of the screw mechanism ball support
Damages around the hole of the ball	Deposit of Ti6Al4V on the bottom surface of the ball. Damages near the hole Circumferential scratches.

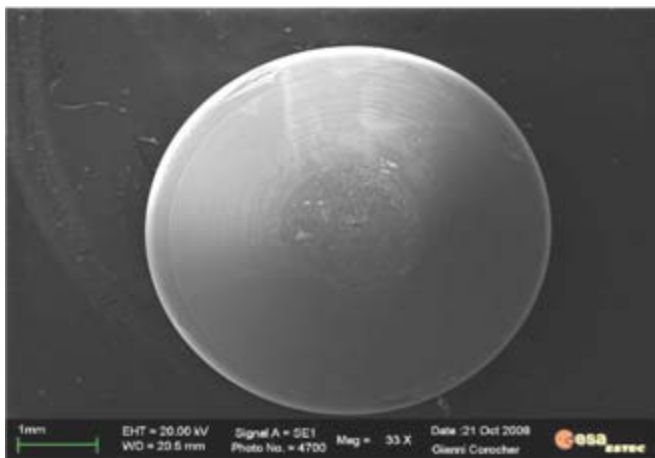
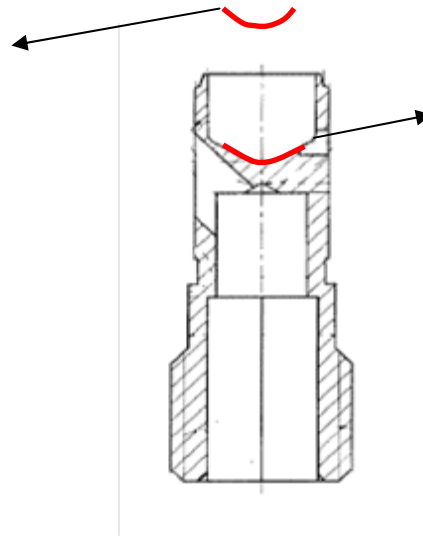
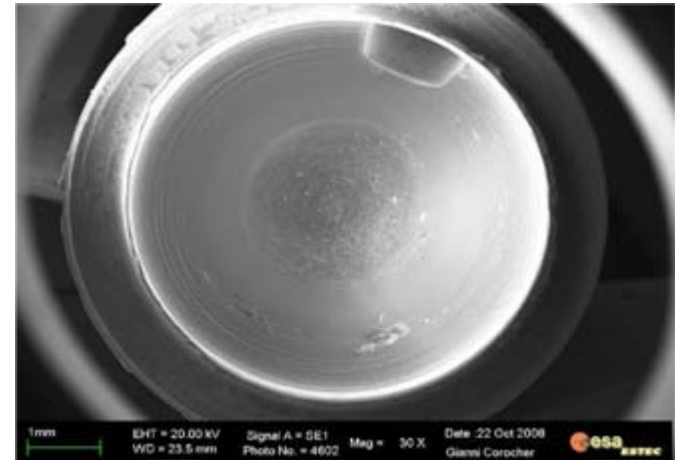
Goce SN 004

- Contact surfaces between the two parts clearly visible and showing evidence of wear and deposit of the ball support material on the housing
